Restoration and Modernization of Ontario's Legislative Building

A Need for Rehabilitation and Preservation

LEGISLATIVE ASSEMBLY
OF ONTARIO

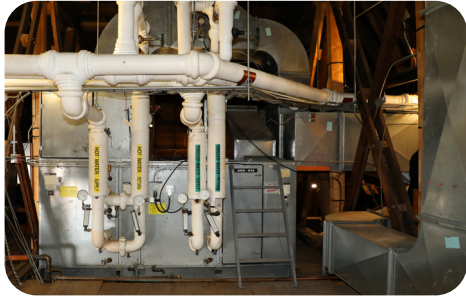
Steam radiator heat is difficult to regulate, areas are too hot or too cold.

Current HVAC units in the attic. They are close to the end of their lifecycle and need to be replaced.

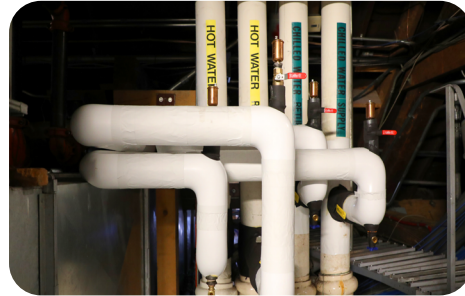
Steam pipes in the attic. Steam heat is inefficient and problematic in the summer months.

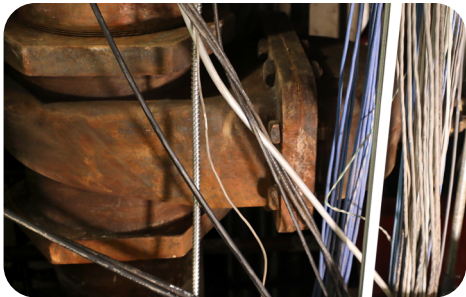
- Much of the drainage piping in the building is original. Pipe ruptures are frequent, causing water damage and costly repairs.
- Interconnected storm and sanitary drainage systems do not meet current regulations. Drainage often backs up during rain storms causing internal flooding and damage.
- Lead pipes make drinking water unsafe.

Original pipes located in the basement ceiling. There are no replacement parts for old pipes if they rupture.

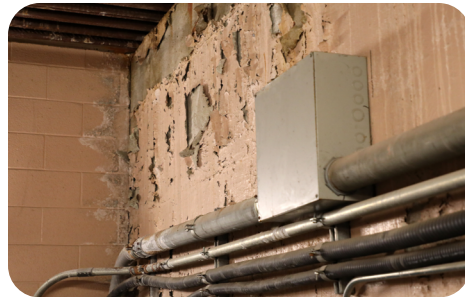
Pipes located in the basement. Leaks and flooding are prevalent with the current pipes.

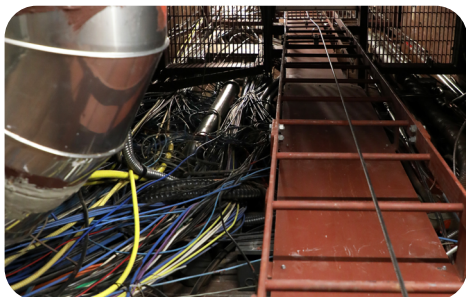
- No plan was implemented when electrical cabling was installed, resulting in severe disorganisation.
- The demand for new services is high, and with the lack of a power and cable management system, any new additions are difficult to administer.
- There is a large amount of redundant and old cabling. It is difficult to discern which ones are current versus obsolete.

Exposed cables located in a ventilation shaft in the basement. Redundant cables are difficult to find amongst the mass of wiring.

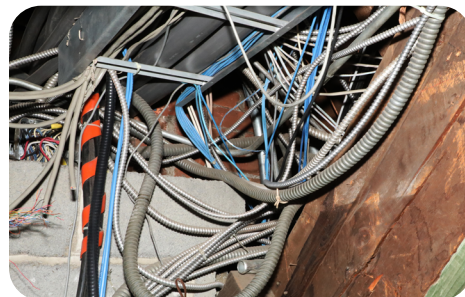
Modern wires exposed in the attic. There is no current cable management plan in place.

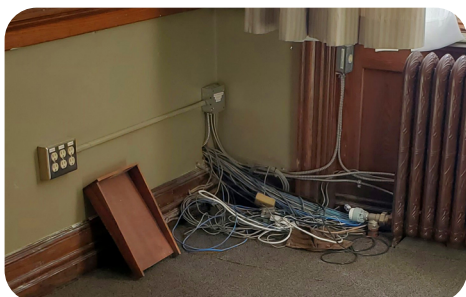
- There is limited and insufficient power supply in some areas.
- There are no consistent lighting levels in the building. Some areas are very dark which is a safety concern.
- There is a lack of supply, consistency and organisation of emergency power.
- Due to outdated technology, it is currently not possible to monitor and manage systems remotely.

Exposed wiring in an office. Insufficient power and outlet locations have led to an overabundance of wiring in offices.

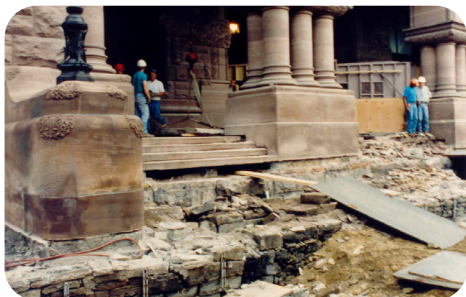
Extensive restoration of the exterior stonework and main entrance in the 1990s. As sandstone is a soft stone, it erodes very quickly.
